LIMITED ASBESTOS INSPECTION REPORT UPDATE

Genesis Hall- Proctoring Center Renovation Lander University Campus

INSPECTION DATE: October 20, 2020
REPORT DATE: October 27, 2020
INSPECTION UPDATE: March 21, 2024
REPORT UPDATE: March 27, 2024

Genesis Hall Testing Renovation

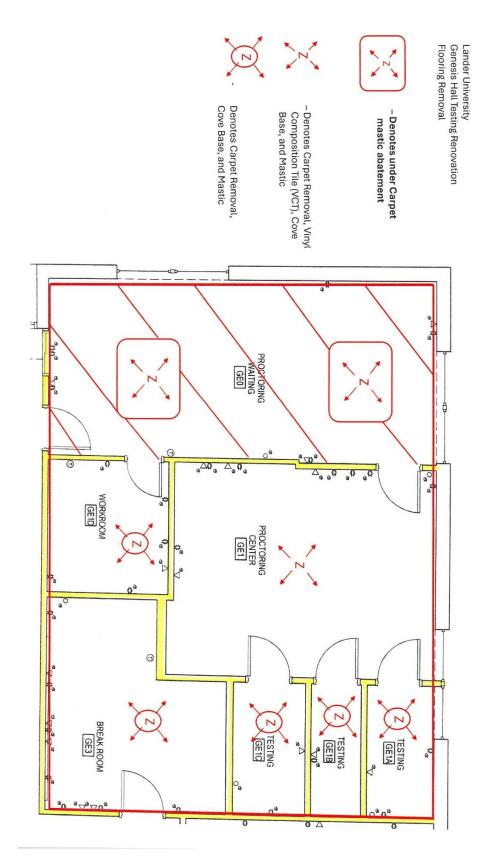
Wall Joint Compound Asbestos Abatement and Demolition

X – Denotes Gypsum Board Abatement and attaching cove
base for length of respective wall for the respective side of
the wall as marked with an (X). Metal Stud wall to remain.

X1- Denotes the Gypsum Board Abatement and attaching cove base removal for length of respective wall. Metal Stud wall to be removed, for the length of the metal studs, to facilitate the floor tile abatement. Typically, these walls have been constructed on top of the Vinyl Composition Tile, VCT.
