LIMITED ASBESTOS INSPECTION REPORT UPDATE

Genesis Hall- Proctoring Center Renovation Lander University Campus

INSPECTION DATE: October 20, 2020
REPORT DATE: October 27, 2020
INSPECTION UPDATE: March 21, 2024
REPORT UPDATE: March 27, 2024

Genesis Hall Testing Renovation

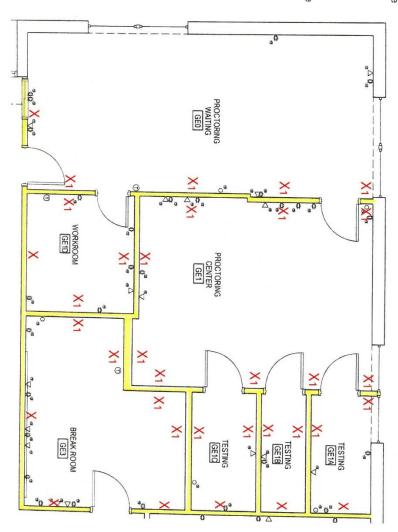
base for length of respective wall for the respective side of the wall as marked with an (X). Metal Stud wall to remain.

X1- Denotes the Gypsum Board Abatement and attaching cove base removal for length of respective wall. Metal Stud wall to be removed, for the length of the metal studs, to facilitate the floor tile abatement. Typically, these walls have been constructed on top of the Vinyl Composition Tile, VCT.
